GRUSON'S
CHILLED CAST-IRON ARMOUR.

BY
JULIUS VON SCHÜTZ,

Engineer of Grusonwerk.

1887.

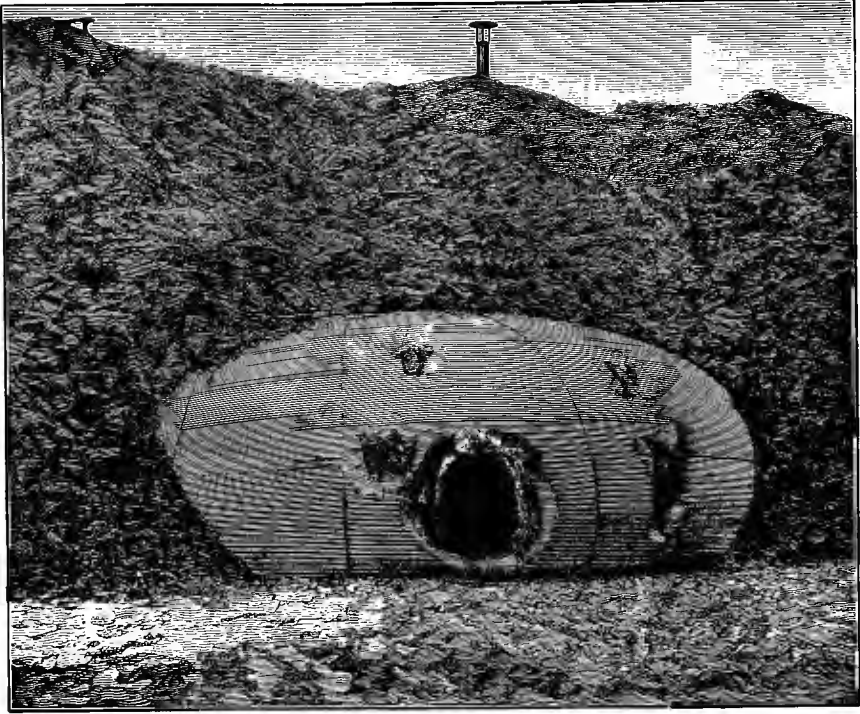
Fig. 9.

The Port Plate of the Armoured Emplacement
for a 72 pounder (8.3 in.) gun after the 15th round, 11/3/69.

The cracks formed were so fine that they do not appear visible in the photograph.

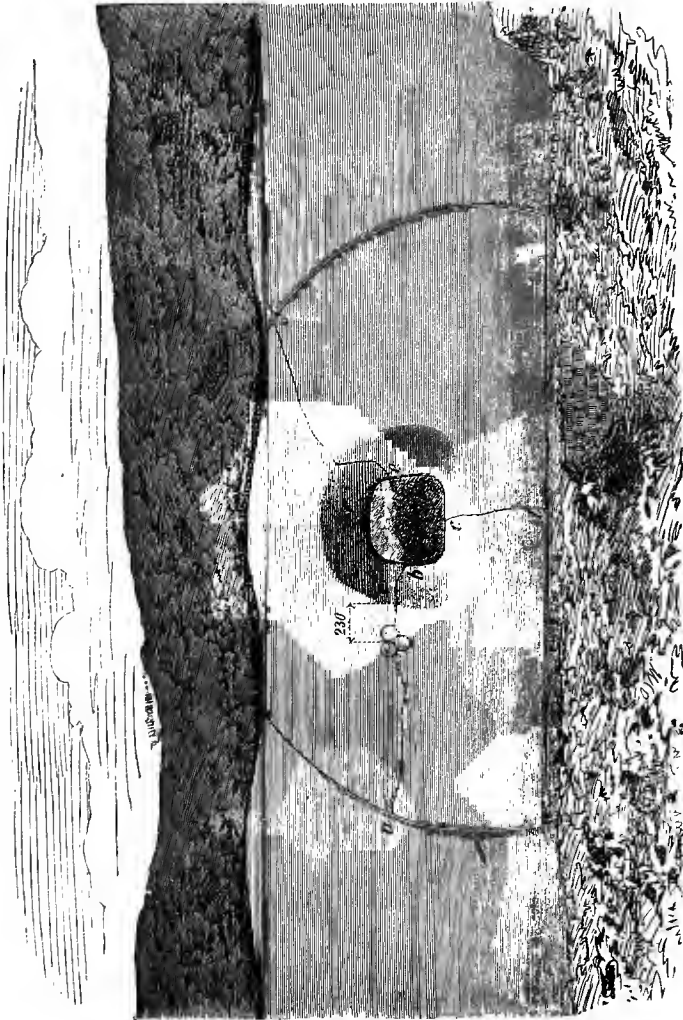
Fig 13.
*The first Port Plate of the Chilled Iron Armour Battery for 8.3 in. (21 cm) guns,
after the third shot, 5/12/73.*

The effect of the first shot was a small and hardly perceptible indent and a short hair crack, and exhibited in a surprising manner the extraordinary reacting power of the material.

The effect of the second shot, which struck on exactly the same place, was cracks a, b, c, about 0.08 in. broad, of which, however, only *a* was visible at the back of the plate. Although the port plate had thus complied with the conditions of the contract, it was decided, on account of the interest attaching to the question, to place a third shot on the same spot, which formed, in addition to a fine crack at the point of impact, the crack e. f.

Summary : The plate had exceeded the conditions of the contract. As however, the result of the trial had thrown no direct light on the total resisting power of the material under prolonged attack, it was decided to have a further trial against the second port plate, and to represent the conditions of warfare by distributing the hits over the surface of the plate.

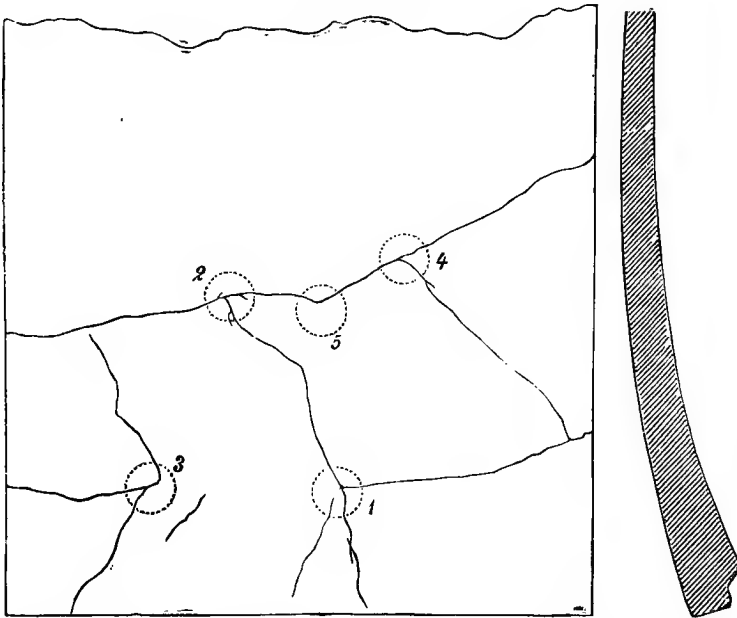
Fig. 15.

*Profile and Position of Hits of the Trial Roof Plate of the Chilled
 Iron Armour Battery for 8.3 in. (21 cm) Guns. 21/8/74.*

Five hits in all were made ; of these the two first only starred the surface, the third cracked the plate as shown, the fourth cracked the plate into two parts, the fifth made no new crack but extended the previous ones to the under surface, and from crack 4 broke off a piece weighing about 2.2 lb. which fell through.

Summary : The Committee declared the plate to have displayed **most satisfactory powers of resistance**, and moreover, considering the small target exhibited by the roof-plate ($\frac{1}{8}$ of the port plate), it was improbable that a ship would be able to place so many hits upon it.

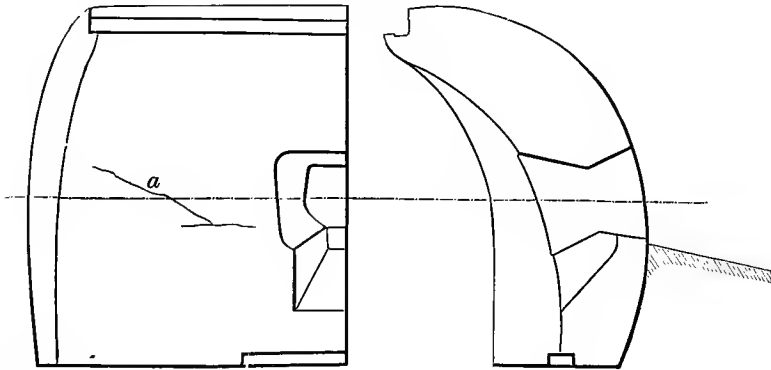
Fig. 20.

Back of the Trial Plate of the Chilled Iron Armour Battery for six 5.9 in. (15 cm) guns, after the fifth shot, 18/8/84.

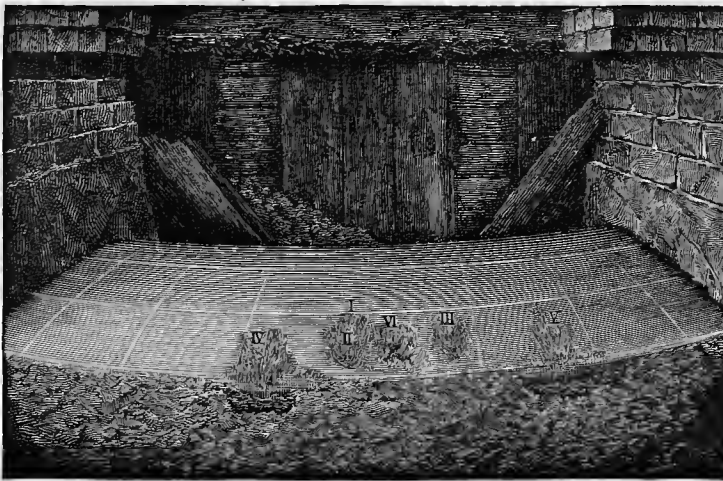
Fig. 22.

The Glacis Plate for an Armour Turret for two 4.7 in. (12 cm) Guns after the 6th round. 12/2/84.

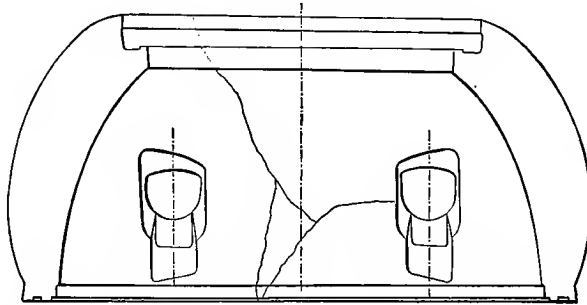
Fig. 24.

*Back of Trial Plate of Chilled Armour Turret for two 4.7 in. (12 cm)
Guns after ninth hit, 28/8/84.*

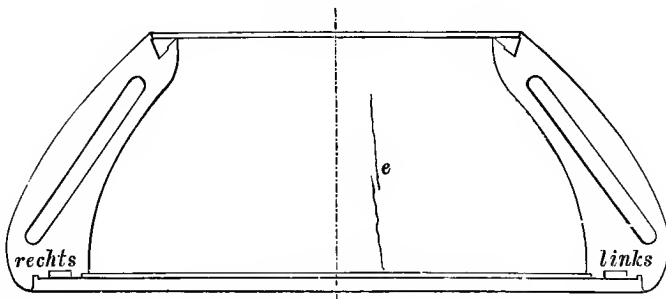
Fig. 26.

Back of Trial Side Plate of a Chilled Armour Turret for two 4.7 in. (12 cm) Guns, after the twentieth round, 20/1/85.

Effect : Indent 4.7 in. broad, and 0.2 in. deep

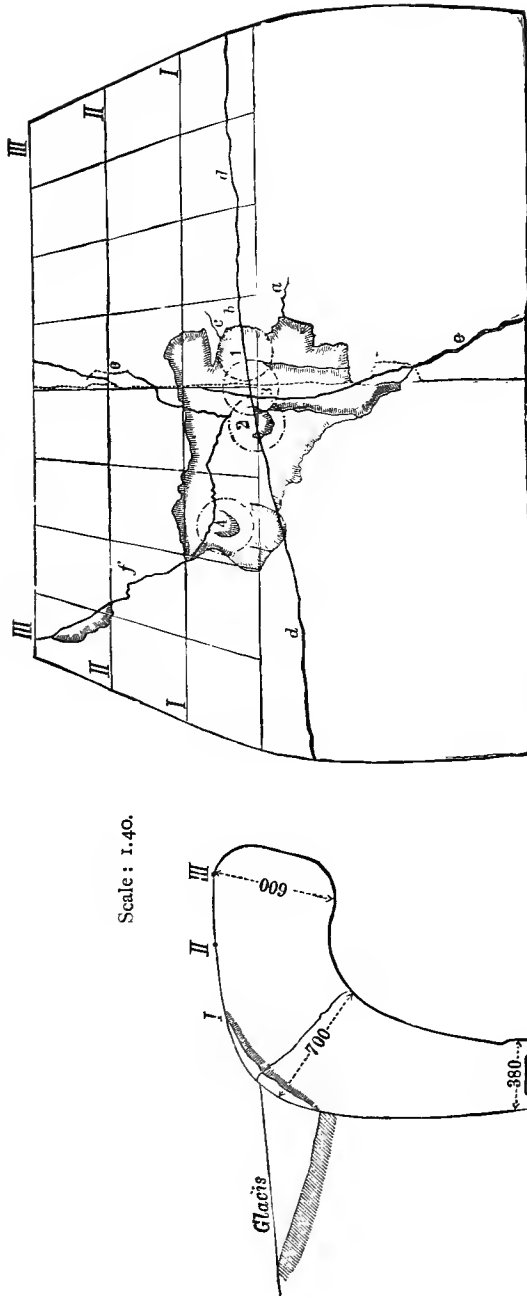
Fig. 28.

Profile and Diagram of hits of the trial glacis Plate of the Chilled Iron Armour Turret for two 12 in. (30.5 cm) guns. 13/8/83.

On inspection of the glacia, it was seen that crack *e*, instead of following, as was supposed, the chill crack, crossed and formed a branch towards the bottom edge of the plate (*see* Fig. 28).

In the upper part of the armour plate the crack *e* followed twice for a short distance the chill crack; but it is to be noted that the plane of fracture was a constant curve, and only joined superficially the irregular zigzag of the chill crack. From this it was clear that the crack *e* was in the interior of the plate entirely independent of the chill crack, as might be expected from the small depth of the chill crack (2.8 in.) in proportion to the thickness of the plate (27.6 in.)

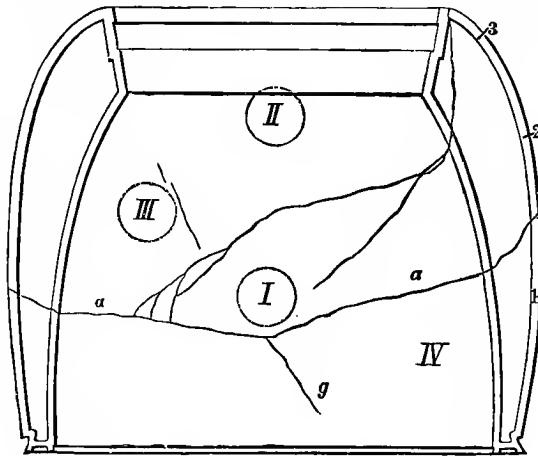
Fig. 32.

Back of the Trial Side Plate of the Chilled Iron Armour Turret for two 12 in. (30.5 cm) Guns after the third round, 22/10/83.

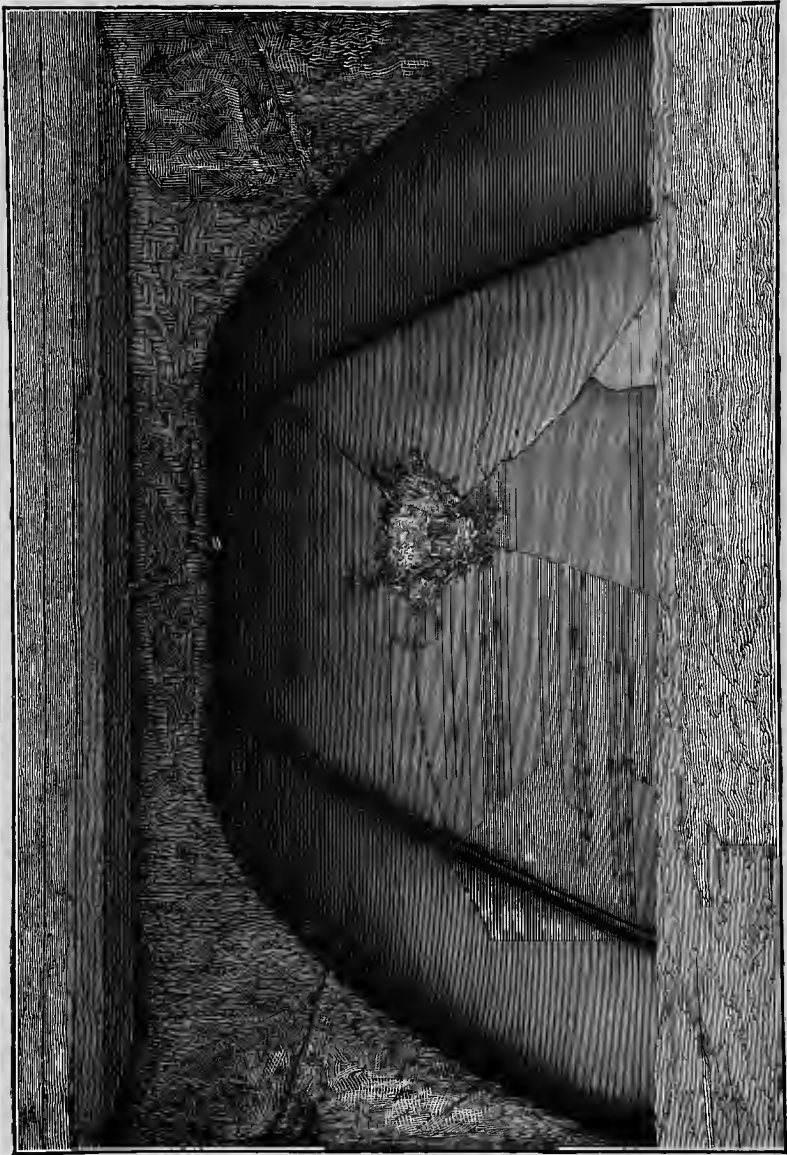
Fig. 39.
*The Side Plate of the Chilled Iron Armour Turret for two 15.7 in. (40 cm) Guns
after the first round. 20/4/86.*

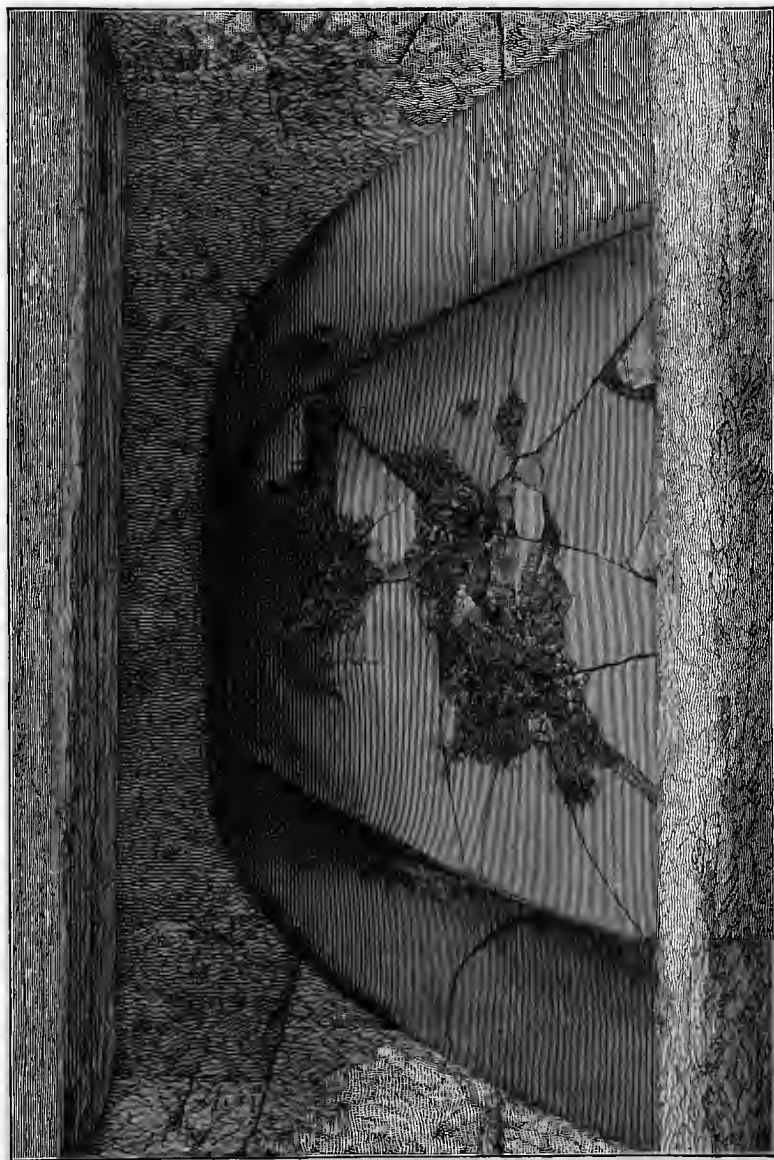
No widening of cracks formed by the previous rounds had occurred.

Fig. 41.
*Side-Plate of the Chilled Iron Armour Turret for two 15.7 in. (40 cm) Guns
after the third round. 29/4/86.*

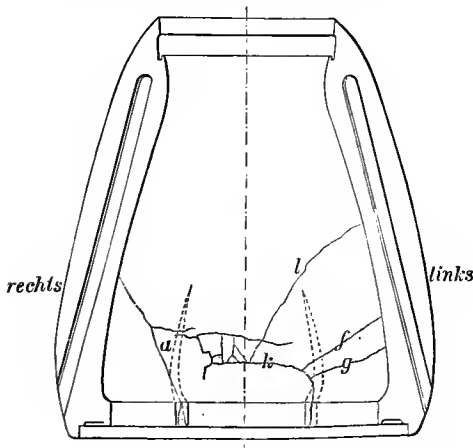
Fig. 42.

Back of the Trial Side Plate after the third round.
29/4/86. Scale: 1.60.

Back of the plate: A new crack running upwards and to the left from the centre line was seen apparently in connection with the hair crack *l* on the front surface; *k* was lengthened to the lower edge of the plate, and between *k* and *b* a nest of several small cracks had appeared owing to which a small wedge-shaped piece weighing about 4.4 lb., shown in dotted lines, had fallen from the inner surface. It measured 3.5 by 4.3 by 3.2 in.

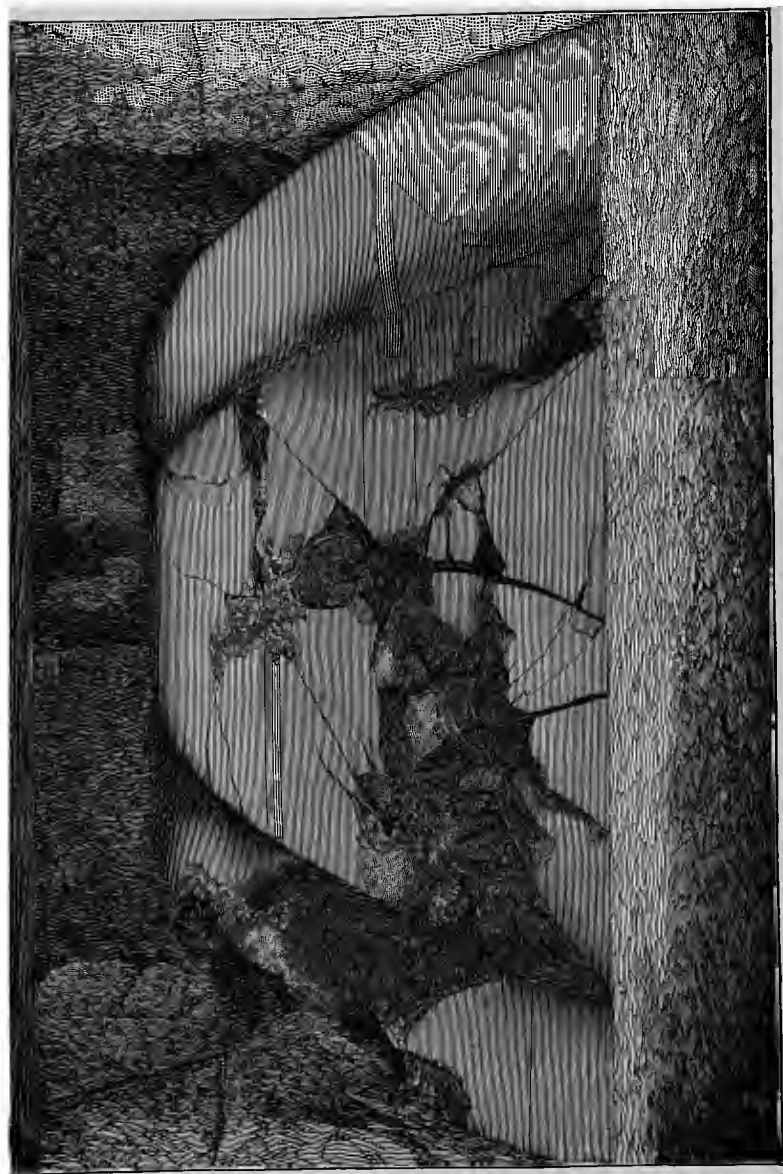
Fig. 44.
*Side Plate of the Chilled Iron Armour Turret for two 15.7 in. (40 cm) Guns
 after the sixth round. 22/6/86.*

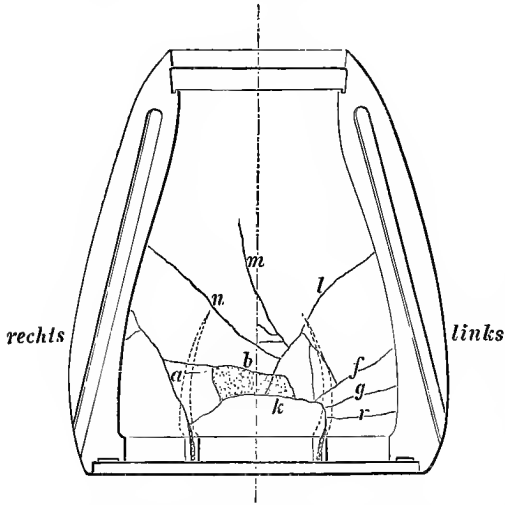
Fig. 45.

*Back of the Trial Side Plate of the Chilled Iron Armour
Turret for two 15.7 in. (40 cm) guns after the sixth round.
22/6/86. Scale: 1.60.*

Summary: The first part of the trial had showed once more that steel shot of small calibre break up on striking an oblique surface of armour, in the same way as the 16.9 in. shell fired in April.
